“Polyisobutylene (PIB) Primary Sealant”

TB-1250-XX

Polyisobutylene (PIB) Primary Sealant

TB-1250-XX, Polyisobutylene and Primary Sealants, Ballot Version August 13, 2018

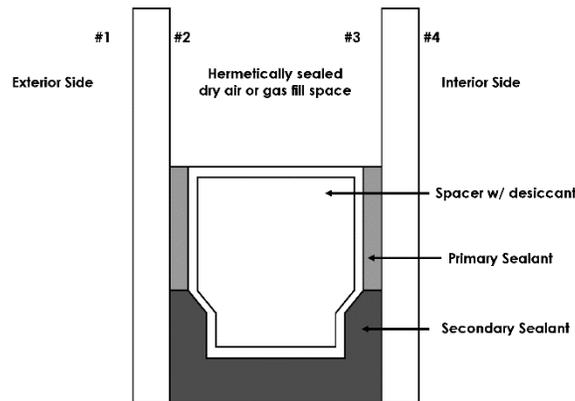
Many IG units (IGU) produced today use a dual seal system made up of a spacer, a primary sealant and secondary sealant. The most important function of the primary sealant is to maintain gas tightness and minimize moisture ingress into the unit. PIB is applied as a seal between the spacer and the glass.

Figure 1.1, Typical Insulating Glass Unit

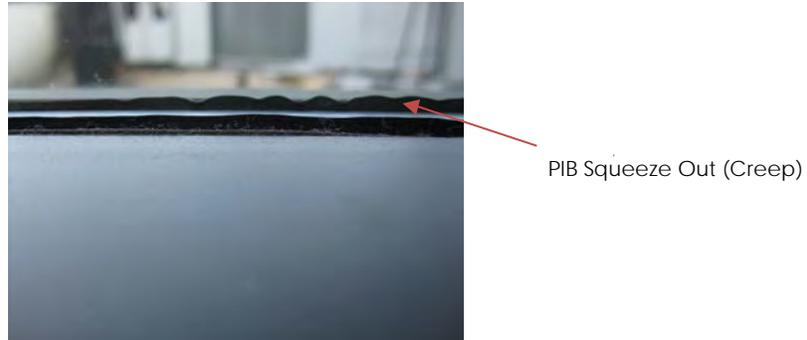
Discussion— Primary sealant infringement within the as-fabricated insulating glass unit should not exceed 1/8 inch (3.0 mm) anywhere along the sightline except at corners, where the primary sealant squeeze out may exceed 1/8 inch (3.0 mm).

Applied pressure at the edge of the IGU can come from a variety of sources including, pressure from a drive-in gasket, a pressure plate framing system, daily pumping action of the IG unit with changes in temperature and barometric pressure, and elevation changes. Applied pressure will result in PIB movement over the life of an IGU. PIB movement can be an aesthetic issue but no data exists to indicate how this may impact the durability of an IG unit.

Figure 1.8.1, PIB Squeeze Out (Creep)

- 2.6 PIB Squeeze-Out vs. PIB Migration: IGMA TM-3100-09 - Voluntary Guidelines for the Identification of Visual Obstructions in the Air Space of Insulating Glass Units, and GANA ID 02-1011 - Guidelines for the Appearance of Insulating Glass Unit Edges in Commercial Applications both include a limit of 1/8 in. (at time of manufacture / or prior to installation) for the infringement of PIB squeeze-out into window sightlines. Since PIB migration is differentiated from squeeze-out primarily due to a change in rheology of the PIB, such limits of infringement do not apply to PIB migration.

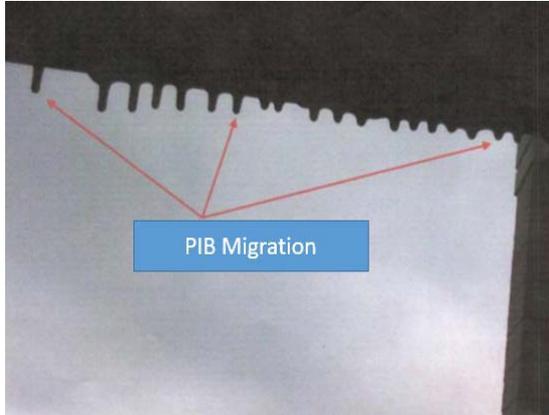
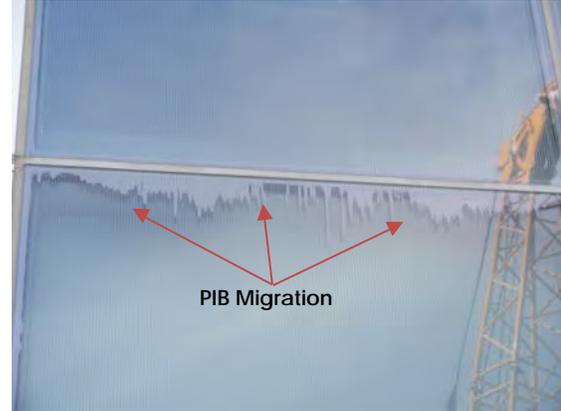
- 1.11 PIB Migration – Progressive or continuous flow of PIB into the vision area of the glass that results from a change in rheology (decrease in viscosity) of the material, after installation.

Discussion--The change in rheology may be attributed to a variety of causes including, solvation or breakdown of the PIB by incompatible glazing components, or degradation of the PIB due to environmental exposure including temperature and UV. In addition to excessive movement into the vision area, it may also manifest as excessive pooling at the spacer.

Figure 1.9.1, PIB Migration

Figure 1.9.2, PIB Migration

PIB migration beyond a limit of 1/2" into the daylight opening may indicate a change in rheology in the PIB and is unacceptable.

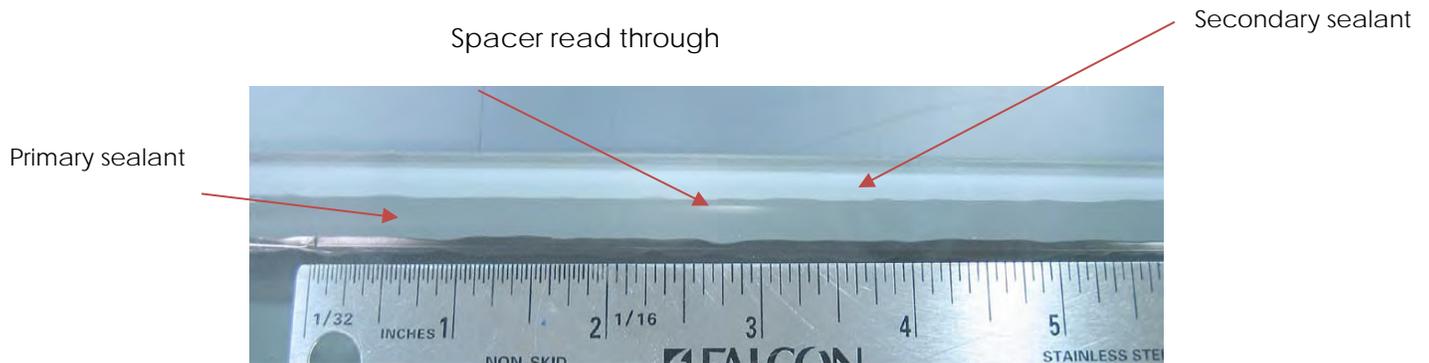
- 3.1 Exposed Spacer Bar: also known as spacer read through.

Figure 3.1.1, Spacer Read through

- 3.1.1.1 Normal Variation
- 3.1.1.2 Poor application or positioning
- 3.1.1.3 Excessive or unequal Edge Pressure on IGU, from glazing or IGU production
- 3.1.1.4 PIB movement capability and adhesion characteristics

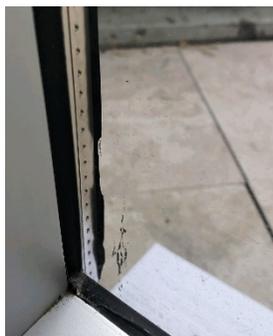
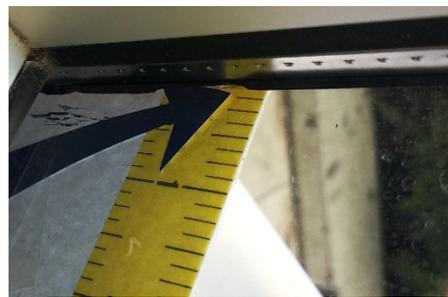
Figure 3.2.1, Primary Sealant in Sightline

Figure 3.2.2, Primary Sealant in Sightline

- 3.2.1.1 Normal variation
- 3.2.1.2 Poor application or positioning
- 3.2.1.3 Excessive or unequal Edge Pressure on IGU, from glazing or IGU production
- 3.2.1.4 PIB rheological characteristics
- 3.2.1.5 Chemical incompatibility with glazing materials

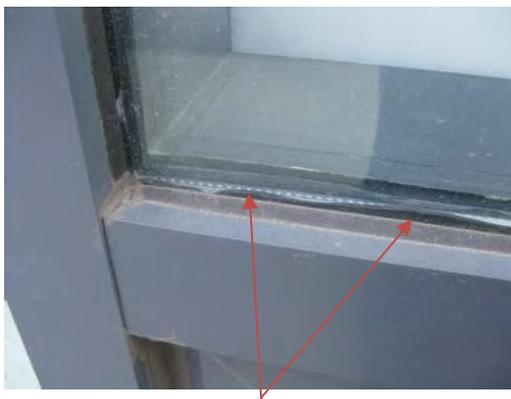
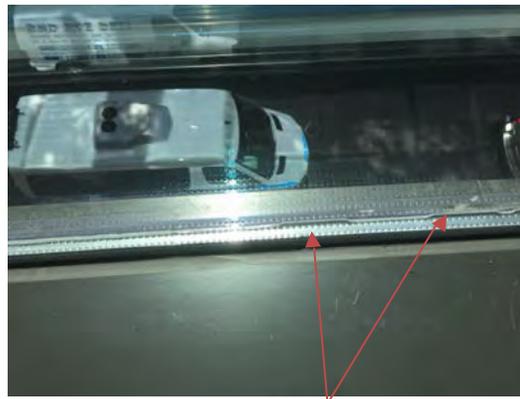
Figure 3.3.1 Black PIB Scalloping

Figure 3.3.2 Gray PIB Scalloping

- 3.3.1.1 Poor application or positioning
- 3.3.1.2 Excessive or unequal Edge Pressure on IGU, from glazing or IGU production
- 3.3.1.3 Movement of IGU due to external pressure differentials (pumping)
- 3.3.1.4 PIB rheological characteristics
- 3.3.1.5 Chemical incompatibility with glazing materials

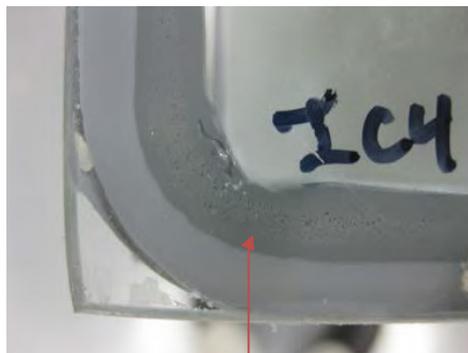
Figure 3.4.2, Bubbles in Sealant

- 3.4.1.1 Normal application variation
- 3.4.1.2 Air in bulk material
- 3.4.1.3 Introduced in pumping system
- 3.4.1.4 Excessive pumping

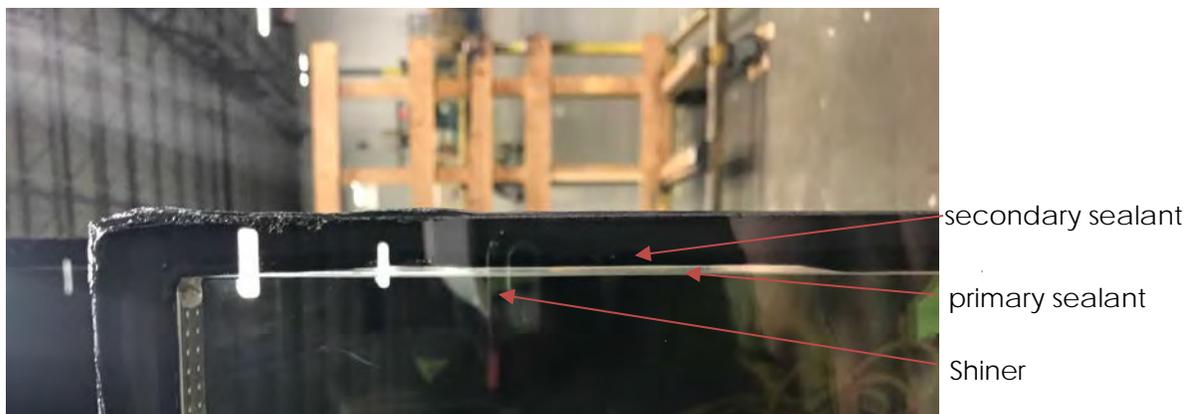
3.6 Shiner: incomplete coverage of the spacer bar by the PIB primary sealant. This can occur at a corner or along the length.

Figure 3.6.1, Shiner

- 3.6.1 Potential root cause:
 - 3.6.1.1 Normal variation
 - 3.6.1.2 Placement of the extrusion of the PIB
 - 3.6.1.3 Can occur with insufficient press out
 - 3.6.1.4 Insufficient amount of PIB extruded
